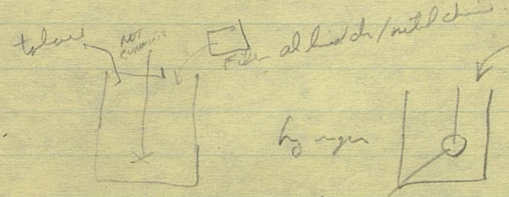
F.S. Pulpit operated
act. bonding of a turning agitator
(grease oil barrier)

for tank cleaning
use of Nomex type
surgical dining gloves
high neck
& long sleeves

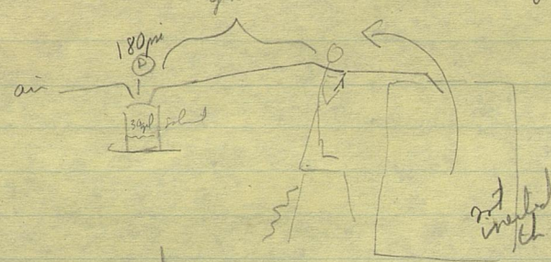
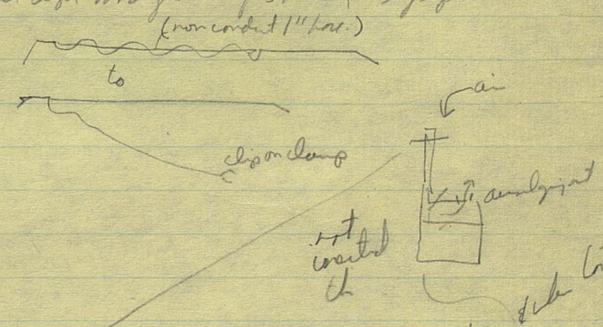
SW
③ pressure cleaning / solvent a 500 g tank

(in an enclosed pipe
transfer flow by <1.5'/sec)

ground-bond holes here. by a maint dept modification of existing equip.

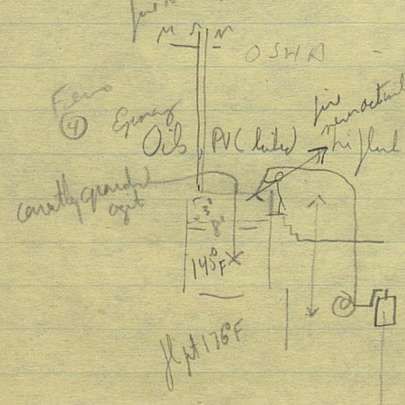
Ferro
④ Epoxy Oils PVC linked

adding a
fiberdrum of
antioxidant
Santicoat - phenol - sulfonamide
3' rope spare a dehydrated sulfide
when added.

other possible source
rubber boots - cloth gloves
developed chg going up & down stairs
he took gloves off & was holding the
the inclinated spark at the edge.
